Investigating the Impact of Bridge Resource Management on Navigational Safety by Root Cause Analysis

Gizem Kodak[1], Almila Dal[2]

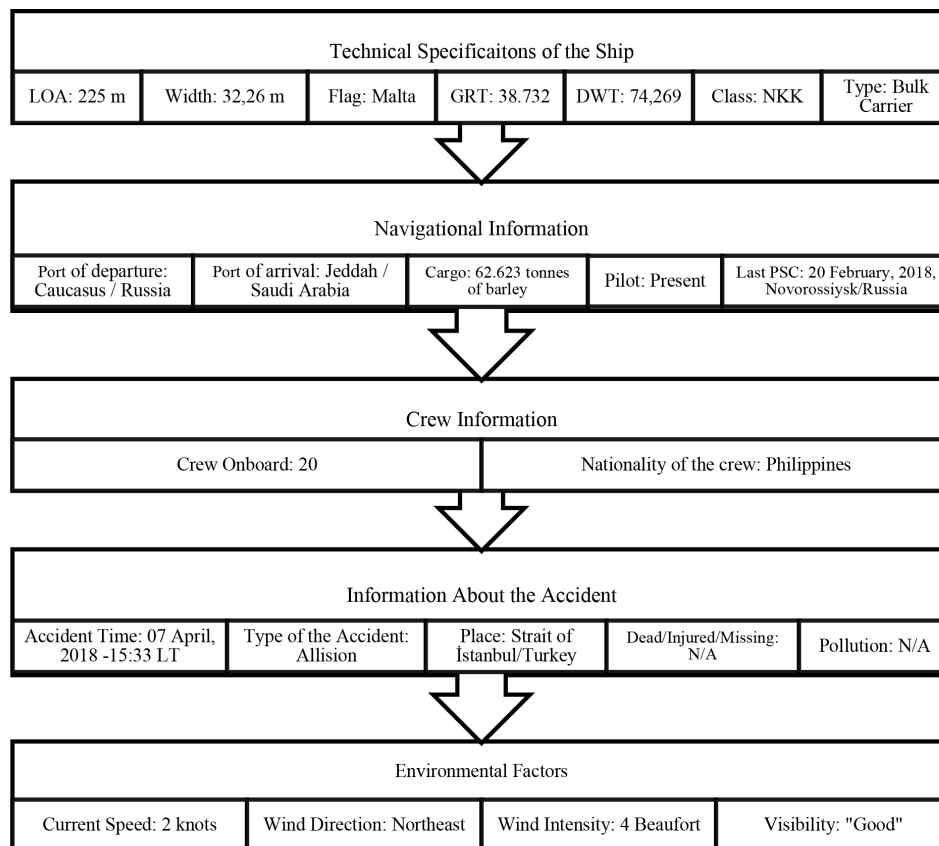
As illustrated in Figure 4, the findings are classified into five distinct categories. These are classified as follows: technical information (including full length, width, type, flag, tonnage and class); navigational information (including departure/arrival, cargo and pilot status); accident information (including accident location, time, type, fatalities/injuries and pollution information); personnel information (including number and nationality of personnel); and environmental factors (including current, wind and visibility conditions). The accident summary analysis, created in accordance with the findings obtained, is presented in Figure 5.

Figure 4. Classification of accident information.

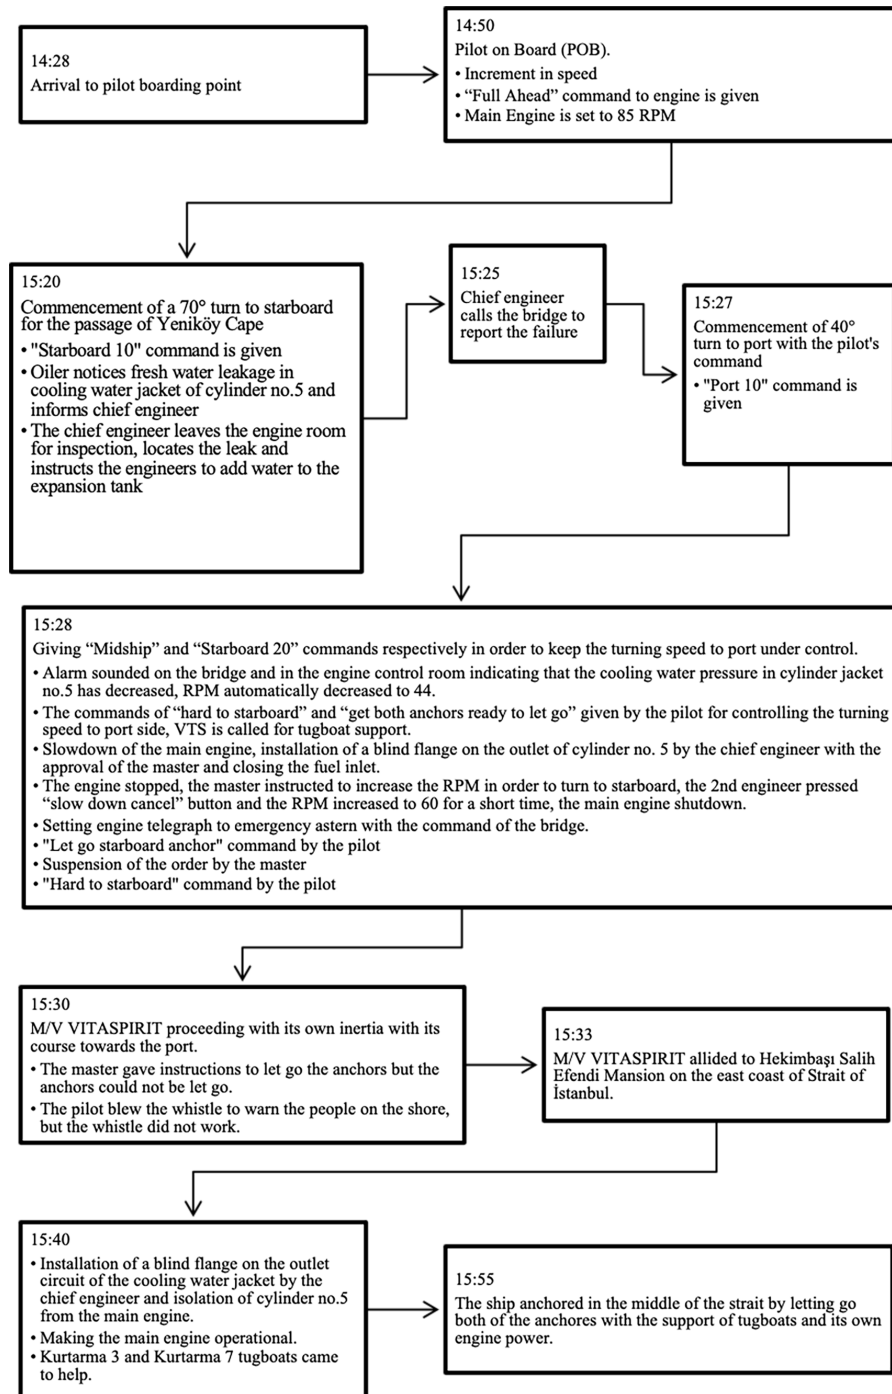
Figure 5. Accident summary review [33].

14:28
Arrival to pilot boarding point

14:50
Pilot on Board (POB).
• Increment in speed
• "Full Ahead" command to engine is given
• Main Engine is set to 85 RPM

15:20
Commencement of a 70° turn to starboard for the passage of Yeniköy Cape
• "Starboard 10" command is given
• Oiler notices fresh water leakage in cooling water jacket of cylinder no.5 and informs chief engineer
• The chief engineer leaves the engine room for inspection, locates the leak and instructs the engineers to add water to the expansion tank

15:25
Chief engineer calls the bridge to report the failure

15:27
Commencement of 40° turn to port with the pilot's command
• "Port 10" command is given

15:28
Giving "Midship" and "Starboard 20" commands respectively in order to keep the turning speed to port under control.
• Alarm sounded on the bridge and in the engine control room indicating that the cooling water pressure in cylinder jacket no.5 has decreased, RPM automatically decreased to 44.

• The commands of "hard to starboard" and "get both anchors ready to let go" given by the pilot for controlling the turning speed to port side, VTS is called for tugboat support.

• Slowdown of the main engine, installation of a blind flange on the outlet of cylinder no. 5 by the chief engineer with the approval of the master and closing the fuel inlet.

• The engine stopped, the master instructed to increase the RPM in order to turn to starboard, the 2nd engineer pressed "slow down cancel" button and the RPM increased to 60 for a short time, the main engine shutdown.

• Setting engine telegraph to emergency astern with the command of the bridge.
• "Let go starboard anchor" command by the pilot
• Suspension of the order by the master

• "Hard to starboard" command by the pilot

15:30
M/V VITASPIRIT proceeding with its own inertia with its course towards the port.
• The master gave instructions to let go the anchors but the anchors could not be let go.
• The pilot blew the whistle to warn the people on the shore, but the whistle did not work.

15:33
M/V VITASPIRIT allided to Hekimbaşı Salih Efendi Mansion on the east coast of Strait of İstanbul.

15:40
• Installation of a blind flange on the outlet circuit of the cooling water jacket by the chief engineer and isolation of cylinder no.5 from the main engine.
• Making the main engine operational.
• Kurtarma 3 and Kurtarma 7 tugboats came to help.

15:55
The ship anchored in the middle of the strait by letting go both of the anchores with the support of tugboats and its own engine power.

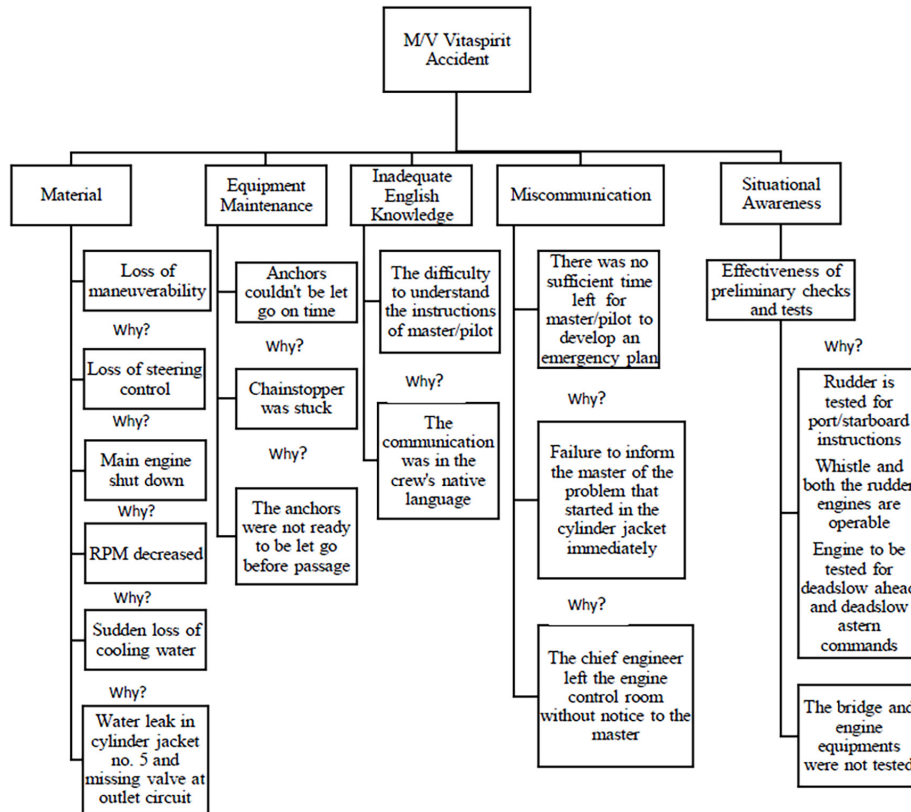
Figure 6. 5 Why technique findings for the M/V VITASPIRIT accident.

The results of the 5 Why technique, which identify potential underlying causes of the MV VITASPIRIT accident in the İstanbul Strait, are presented in Figure 6.

When the accident findings evaluated by the participants were analyzed within the scope of the 5 Why technique, it was seen that the root causes of accidents were grouped under five categories. The first category is analyzed in terms of equipment maintenance and materials. According to this, the most superficial reason why the ship allided to the

mansion is that no effective maneuver could be made to avoid the accident. Under the 5 Why technique, the question of why no effective maneuver could be performed is explained by the loss of the ship's steering ability. When the question of why was asked for the second time, it was found that the reason was that the main engine shutdown. The question asked about why the main engine shutdown is explained by the drop in RPM. The fourth why question indicated that the reason for the drop in RPM was the sudden loss of cooling

water. When the question was asked for the fifth time, it was discovered that this situation was due to a water leak in the cylinder jacket number 5. So at the end of the process of the 5 Why technique, it was concluded that one of the root causes of the accident was the material and the equipment. The corresponding process is shown in Figure 7.

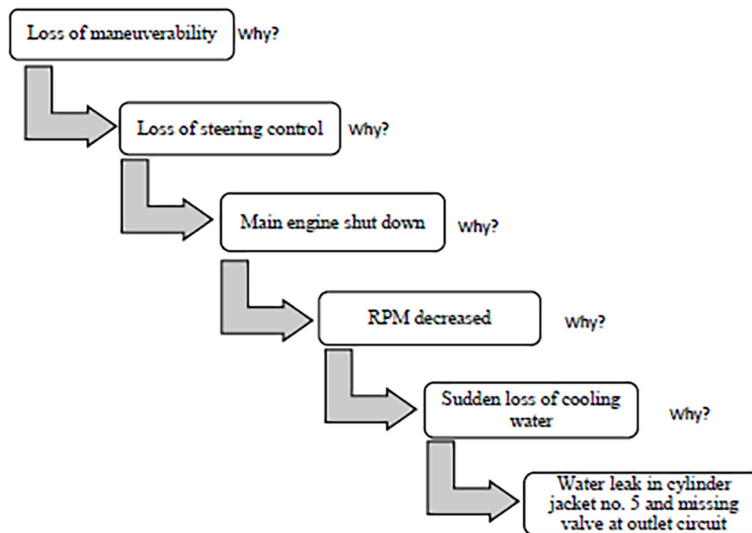
Figure 7. Identification of sub-causes: Material.

the ship, which was the subject of the accident. The water leak in the cylinder jacket, the inability to release the chain stopper running over the anchor chain as commanded let go and consequently the inability to let go the anchors in time to counter the forward motion of the ship, as well as the observation that the ship's whistle did not work when instructed, indicate the lack of maintenance and preparation of the ship's components/parts.

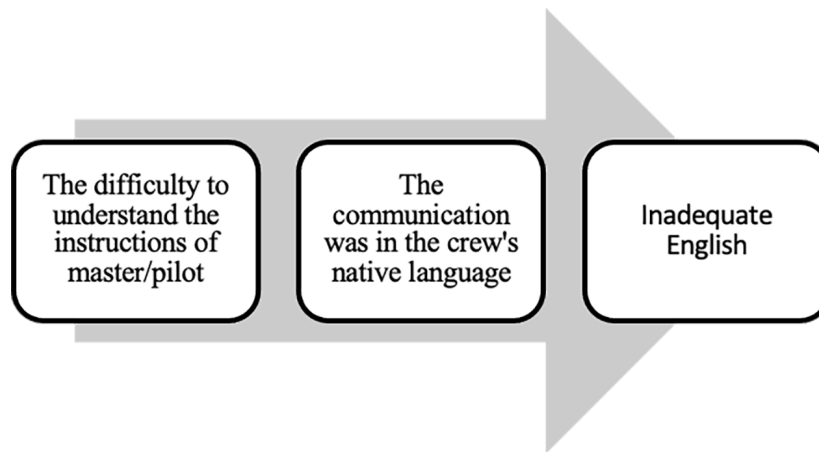
**Figure 8.** Identification of sub-causes: Miscommunication/insufficient English.

It is considered that miscommunication due to inadequate English within the scope of BRM was another main factor that caused the accident. Accordingly, in the process that started with the problem at cylinder jacket number 5 and turned into an accident when the necessary action could not be taken at the right time; it is considered that one of

the possible main causes of the accident was the difficulty encountered by the crew in understanding the pilot's orders. The "why" question asked for this problem is explained by the fact that communication on board is mostly done in the native language of the crew. The re-asked why question leads to the conclusion that the root cause of the communication difficulty is inadequate English. The related process is shown in Figure 8 below.

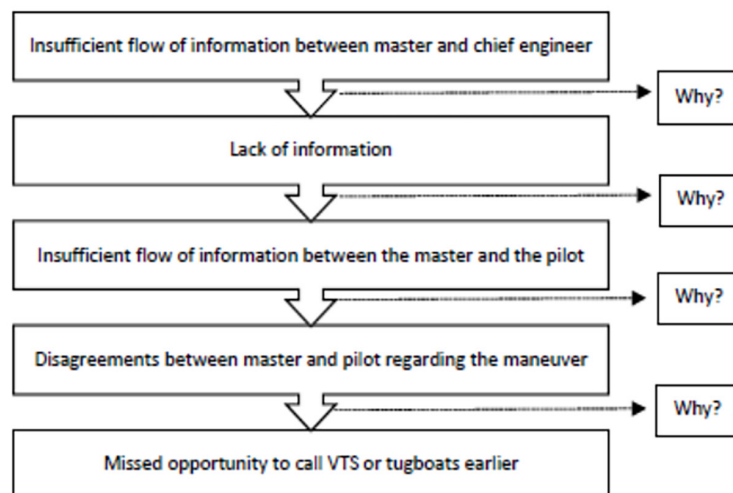
Figure 9. Identification of sub-causes: Miscommunication - lack of information flow.

Within the scope of BRM, the lack of effective management of the information source created another miscommunication between the master / pilot and master / chief engineer. It is considered that this situation changed the course of the accident by missing the opportunity to call vessel traffic service and tugboats for help earlier. The findings obtained within the scope of the 5 Why technique regarding the process are shown in Figure 9.

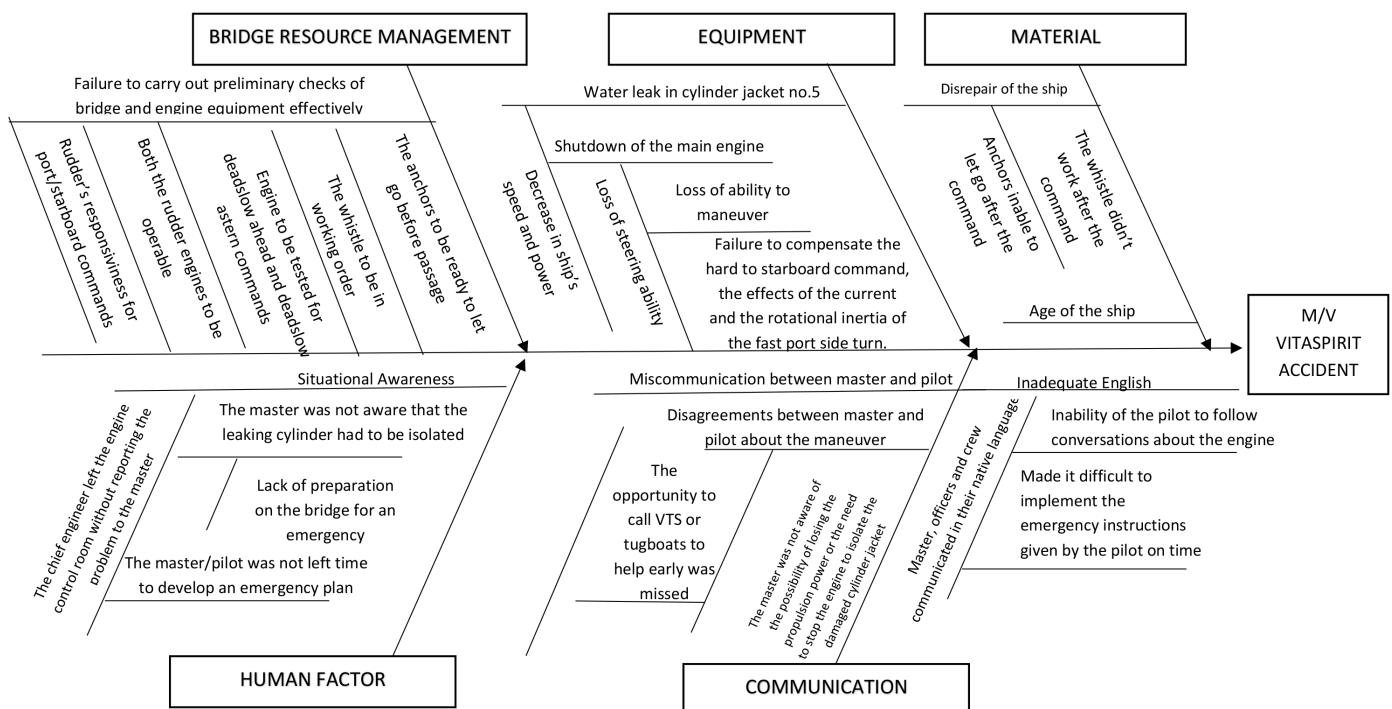
Figure 12. Fishbone Diagram of the root causes of the M/V VITASPIRIT accident.

Equipment: Due to the water leakage that started in cylinder jacket number 5, the engine power and speed decreased, resulting in the shutdown of the main engine. This situation has weakened the steering ability of the ship and eliminated the maneuvering capability.

Human Factor: The results of the research draw attention to the fact that the human factor is determinant on the accident, especially within the framework of situational awareness. In this respect, the chief engineer's leaving the engine control room without informing the master in order to intervene in the water leakage that took place in the number 5-cylinder jacket is considered to be one of the critical factors affecting the course of the accident. This situation caused the master to be unaware of the need to isolate the leaking cylinder and revealed the lack of preparedness for emergency situations on the bridge. The time loss in this process also left no time for the master and pilot to develop an emergency plan.

Communication: The results obtained within the scope of the study support the conclusion that the lack of effective communication between the master and the chief engineer and between the master and the pilot were the factors that paved the way for the accident. The chief engineer's failure to provide immediate information resulted in the master not being aware that the propulsion power might be lost or that he would have to stop the engine to isolate the damaged cylinder

jacket [44]. This situation also triggered a disagreement about maneuver between the master and the pilot. However, it was found that inadequate English was a critical factor in the accident. Although the working language onboard was English, the fact that the vessel's crew communicated in their native language made it difficult for the pilot to follow the engine-related conversations and for the crew to understand and implement the emergency instructions given by the pilot in a timely manner. The fishbone diagram formed according to the findings is shown in Figure 12.
